Manhole Inspection Summary

Manhole # S37II1010MH

Insp Date: **1/11/07 10:09 AM**

Location Address: **4 GREENMOUNT AVE**

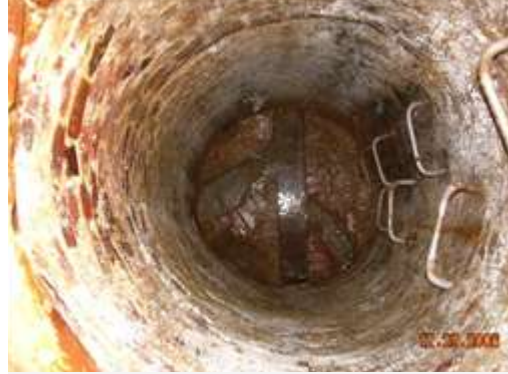
Top View

Corroded steps. Evidence of surcharge - Bench debris. Channel debris.

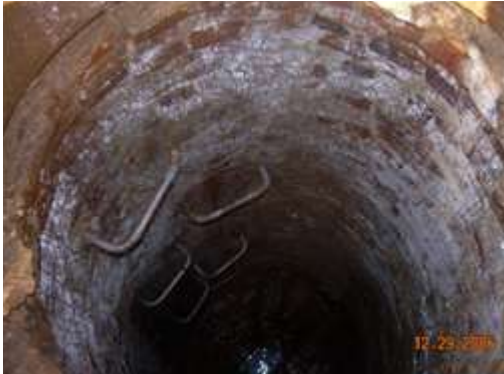
Defect

Frame leaks. Frame offset. Adjustment deterioration and infiltration. Barrel infiltration.

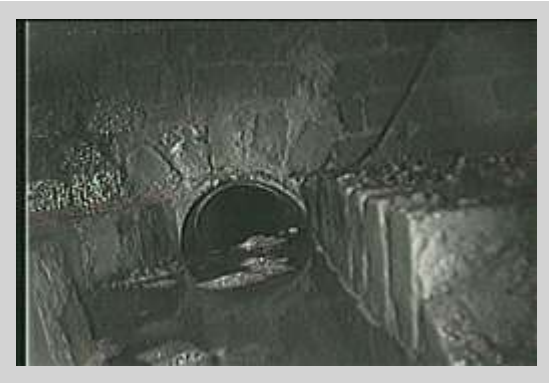
8 in. Circular Gravity Sewer Pipe Out @ 12 O'Clock

Deposits: ☐ None ☒ **Mud** ☐ Sludge ☒ **Debris** ☐ Grease

Silt Depth: **3** (in.) Deposits Extent: **Medium**

Infiltration: **Evidence** Pipe Seal Cond: **Cracked**

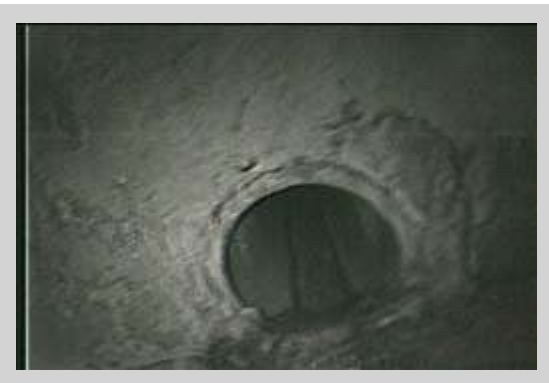
6 in. Circular Gravity Sewer Pipe In @ 5 O'Clock

Infiltration: **Evidence** Pipe Seal Cond: **Cracked**

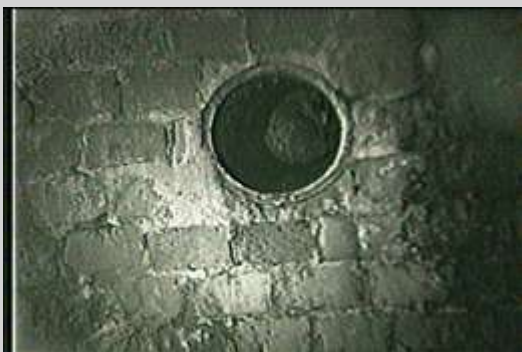
Pipe In @ 9 O'Clock

Barrel deterioration and infiltration.

Deposits: ☐ None ☒ **Mud** ☐ Sludge ☒ **Debris** ☒ **Grease**

Infiltration: **Evidence** Pipe Seal Cond: **Unknown**

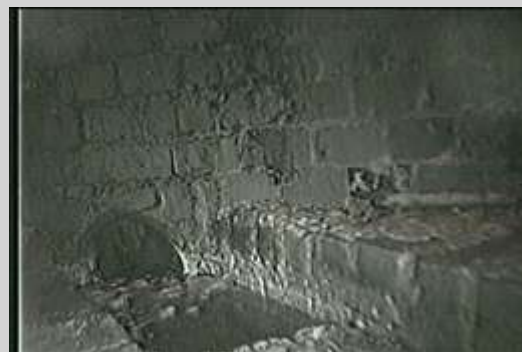
Drop In @ 9 O'Clock

Drop: **Outside** Rod and Bar

Drop Condition: **Open**
